A BRIDGE in a Garden

BY TOM PINDER

A small yet crucial bridge in a Hawaiian state park is installed quickly and with minimal impact to the surrounding rainforest.

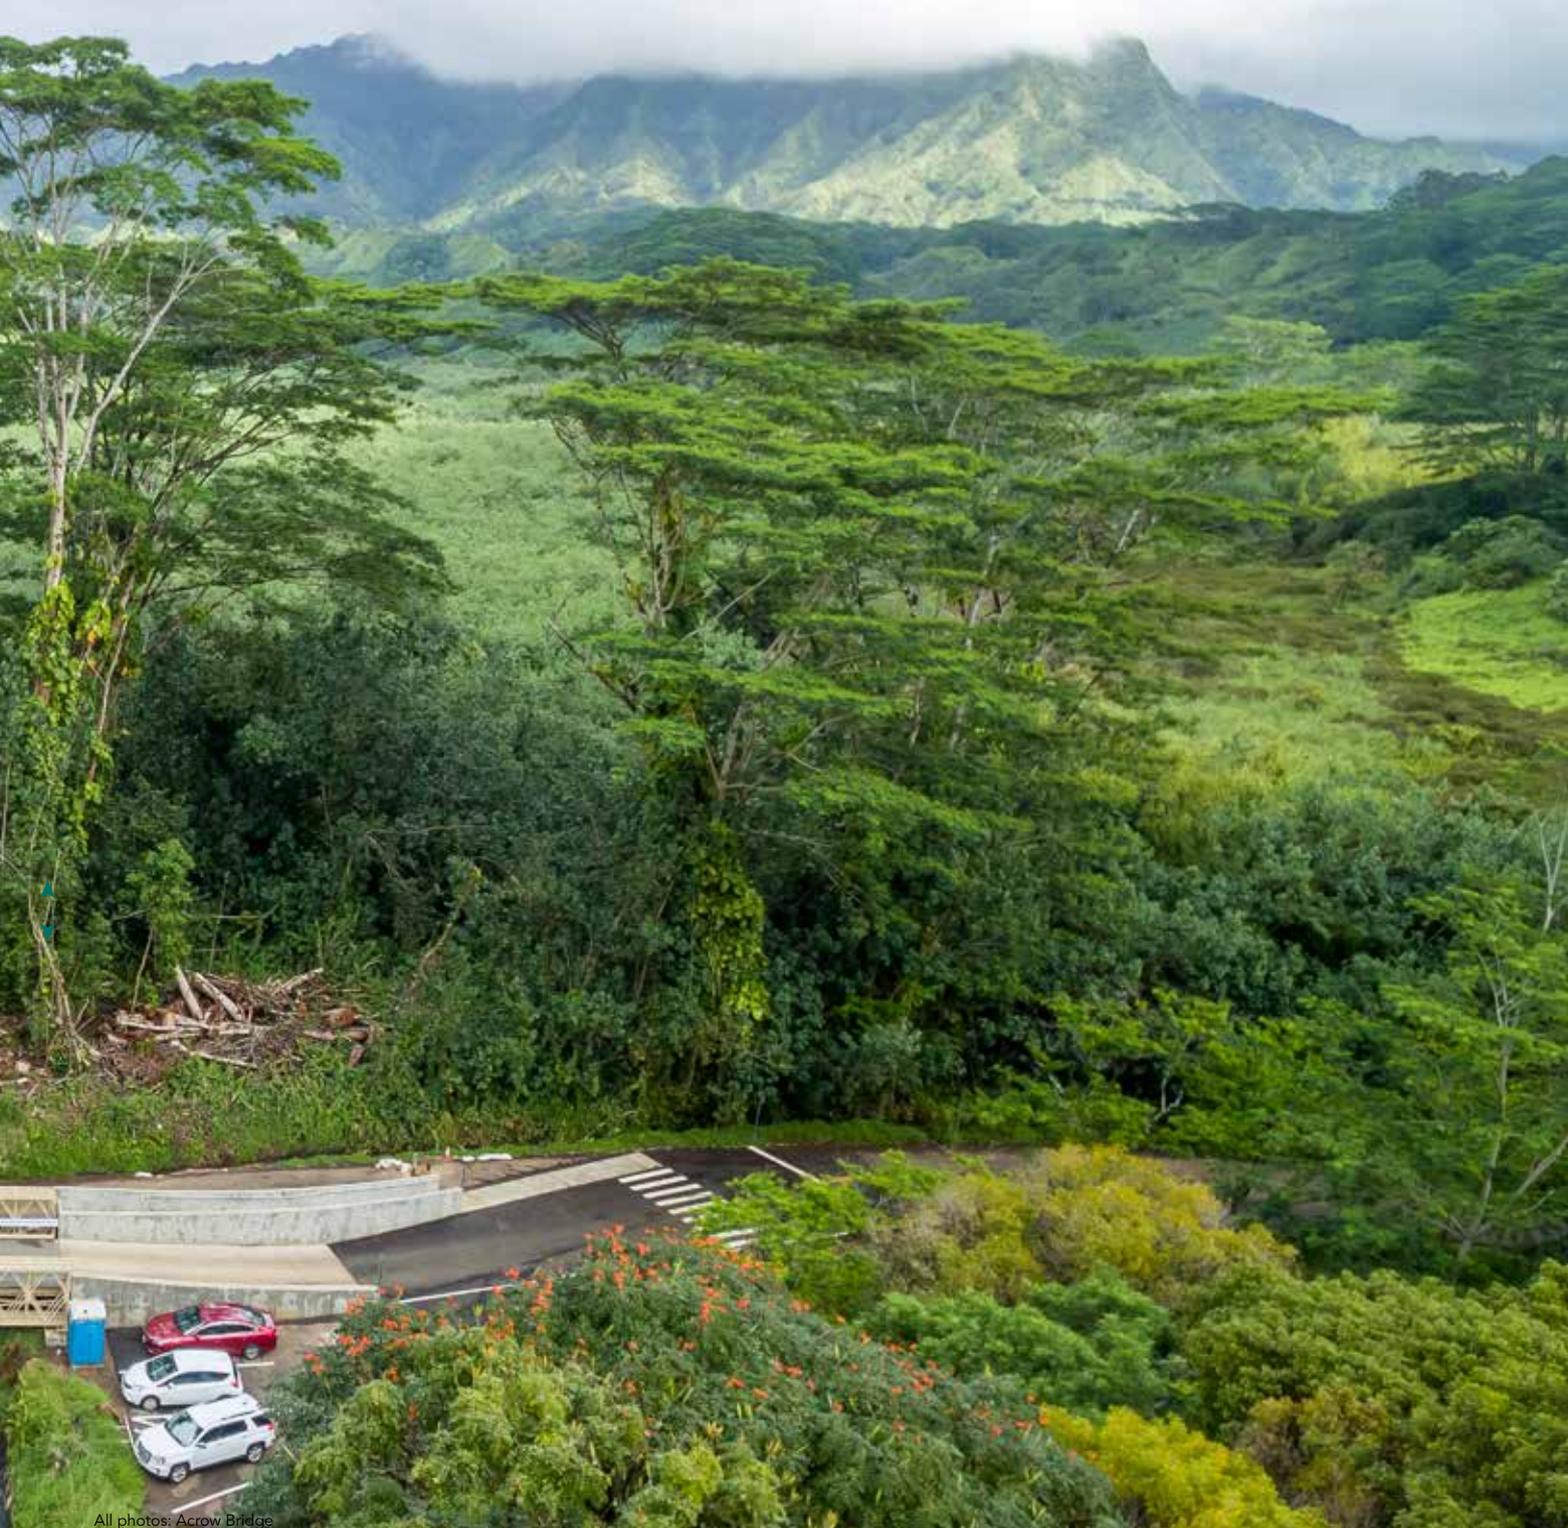
▲ A new bridge replaces a concrete roadway that had sunk into the stream over time and often flooded after heavy downpours.

The original route in and out of the preserve, which crossed the Keahua Stream, was a concrete roadway that had sunk into the stream over time and often flooded after heavy downpours, rendering safe passage difficult if not

impossible during the rain-heavy winter and spring months in this remote but highly traveled area. A new bridge was needed to provide a safer route during these high-water events so cars would no longer be stranded if they were on the mountain side of the river or washed out trying to cross the existing ford during flash flooding.

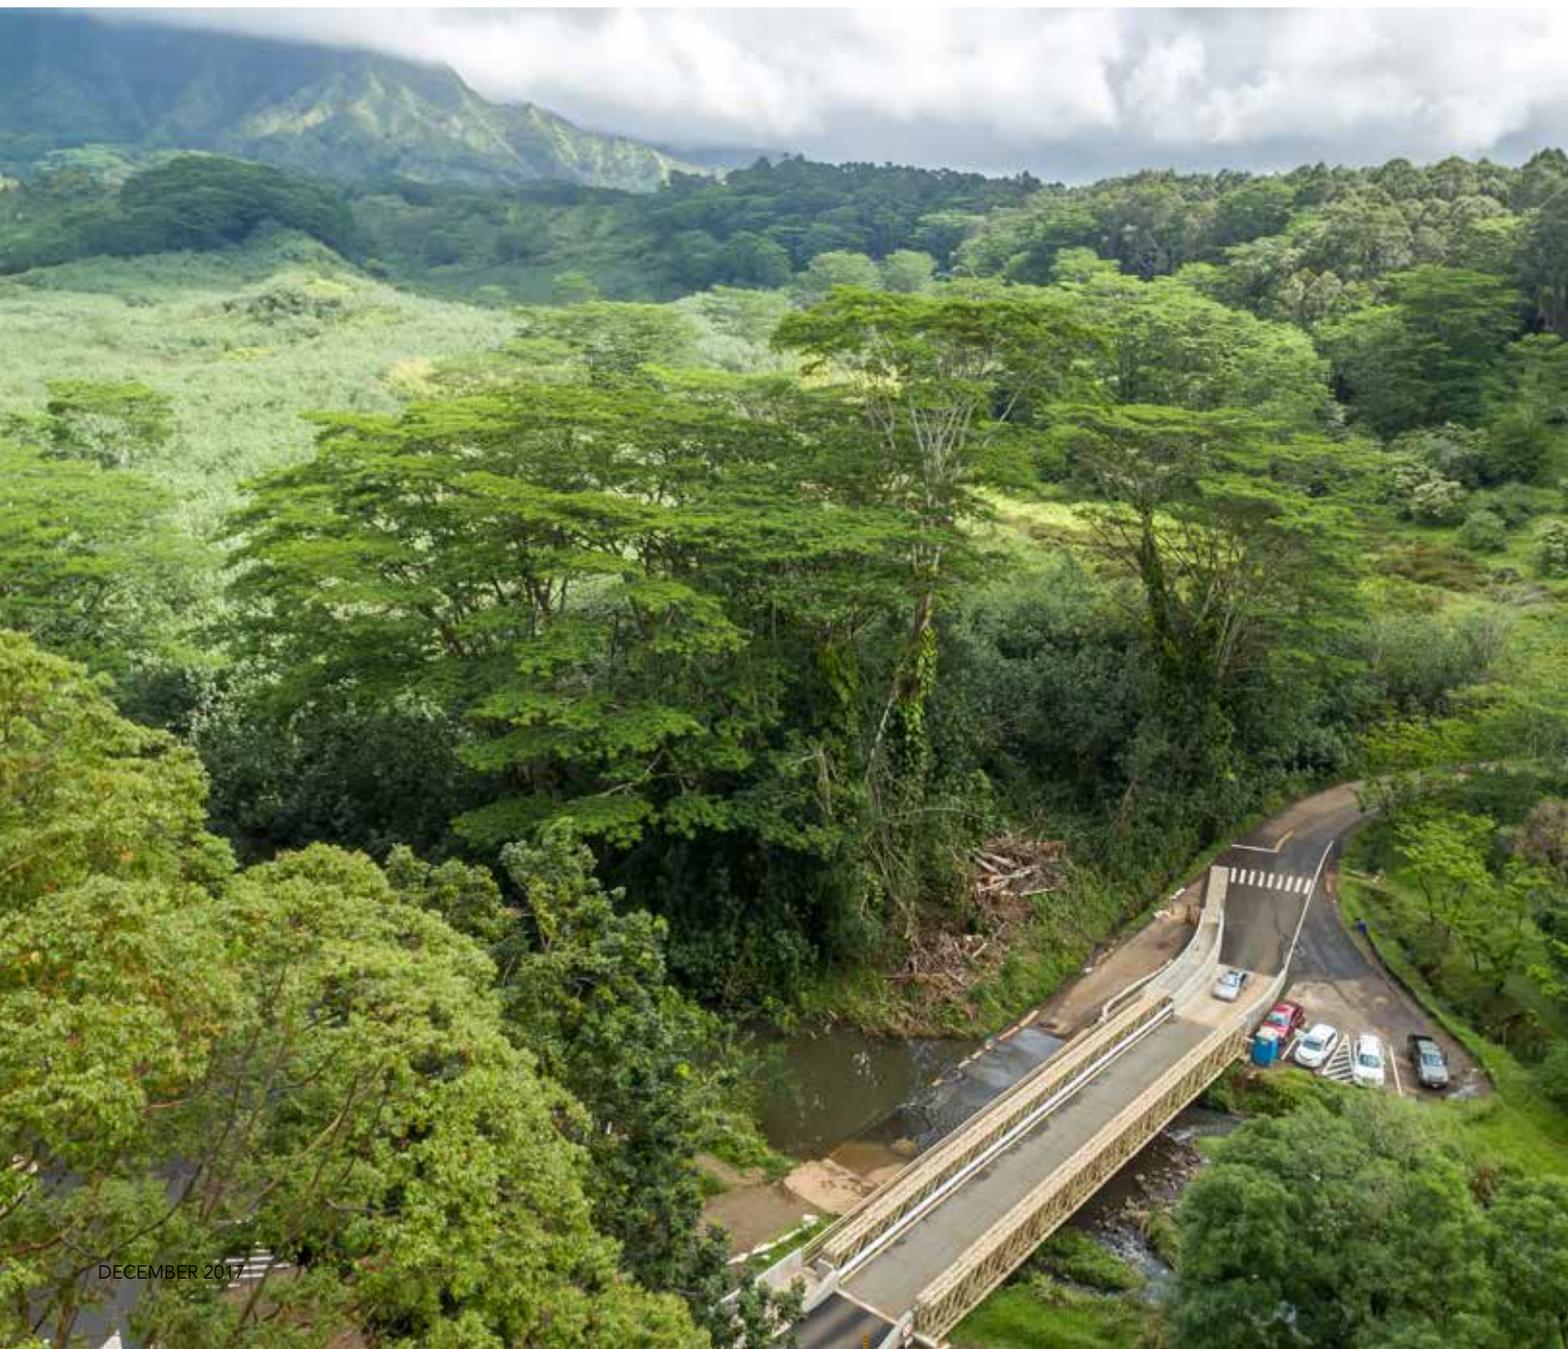
-
- ▼ The 110-ft-long single-lane bridge also includes a sidewalk on one side, separate from the roadway, creating a safe crossing for pedestrians.

Hawaii's Department of Land and Natural Resources (DLNR) decided to construct a permanent bridge at the site, along with a new roadway alignment and a drainage culvert with an inlet and outlet. The 110-ft-long single-lane bridge also includes a sidewalk on one side, separate from the roadway, creating a safe crossing for pedestrians.

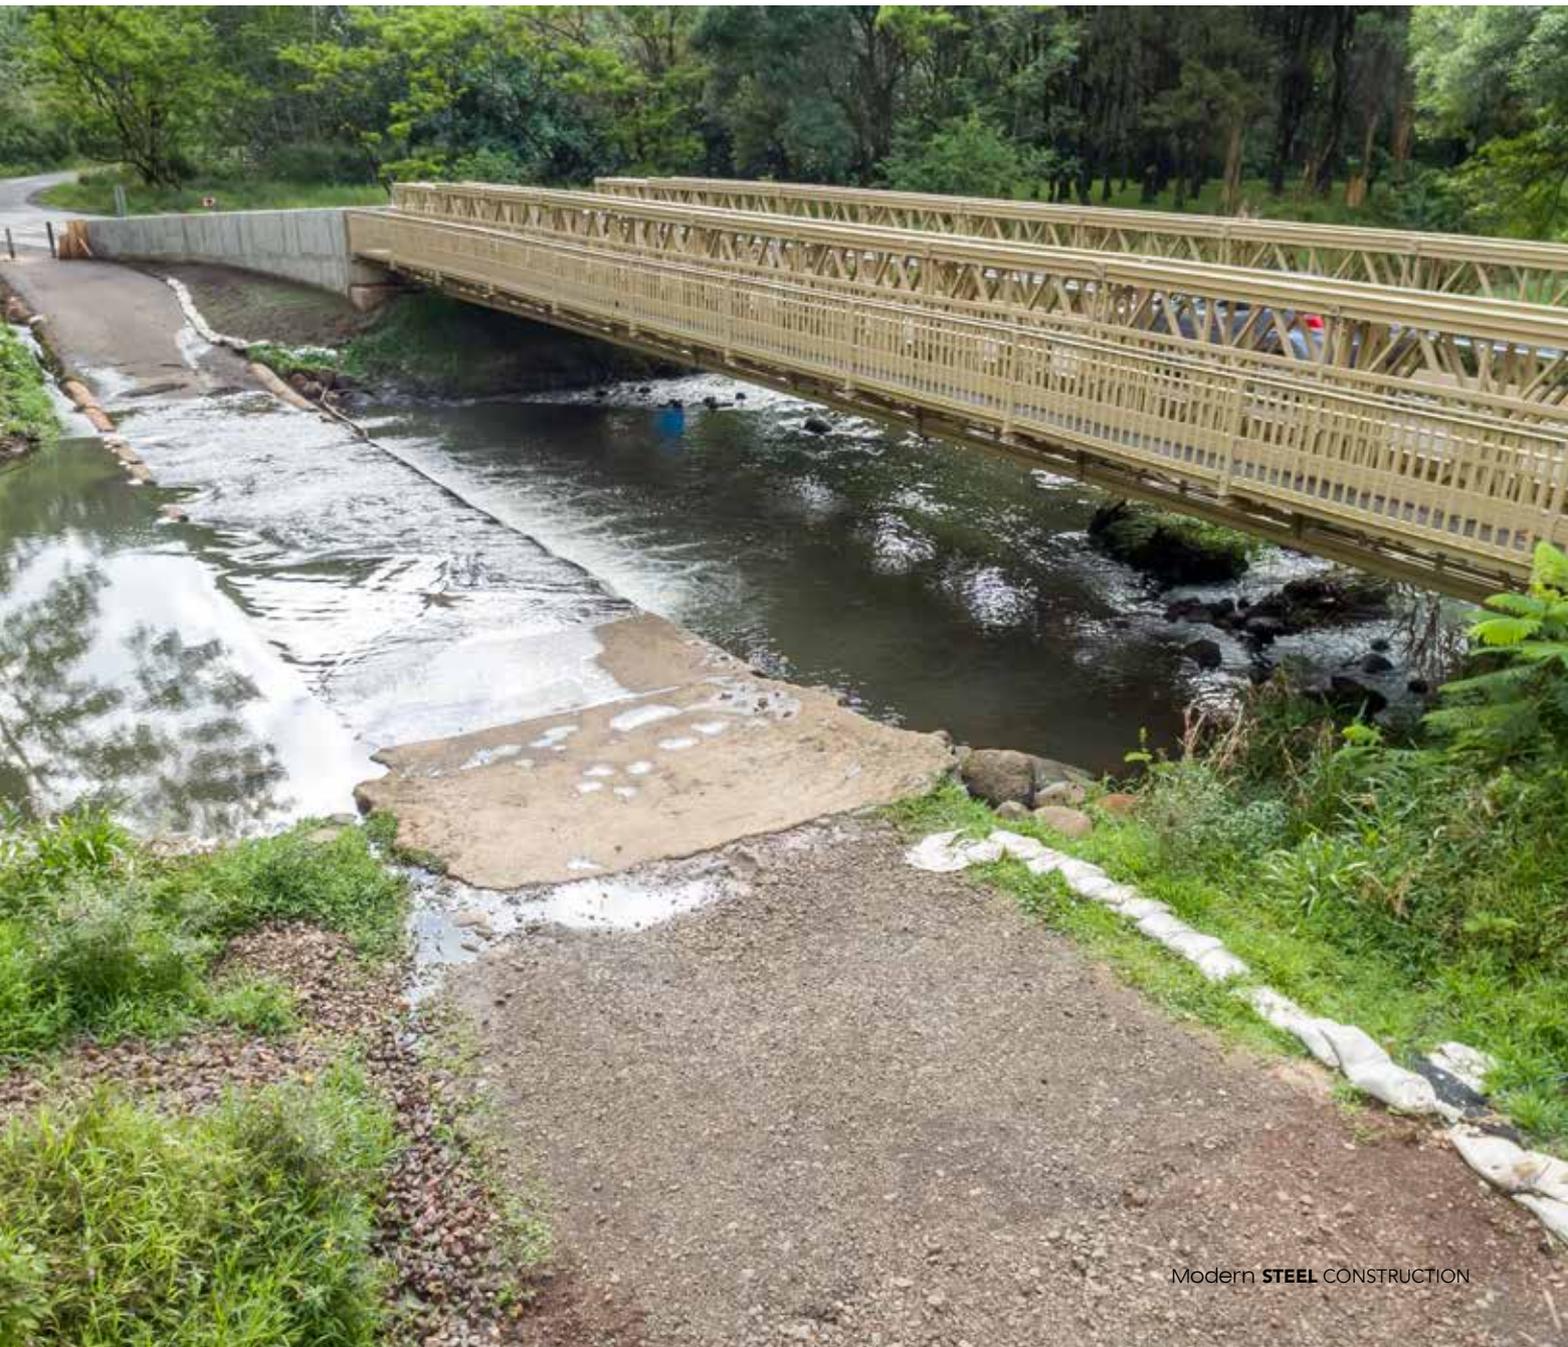
✔ Modular components allowed for ease of shipping, parts staging and assembly in this remote region with a tight build area.

Modular construction. Modular components allowed for ease of shipping, parts staging and assembly in this remote region with a tight build area. Large cranes are not commonly available on Kauai, but this did not pose a problem since the

contractor was able to build the structure in situ on falsework in the shallow stream while requiring minimal space for laydown and construction. The modular approach also reduced the potential of damage to the painted sections. All bridge elements were packed into 40-ft shipping containers at Acrow's facility in New Jersey and shipped directly to Kauai.
